DOT/FAA/AR-99/7

Small-Engine Uncontained Debris Analysis

February 1999

Final Report

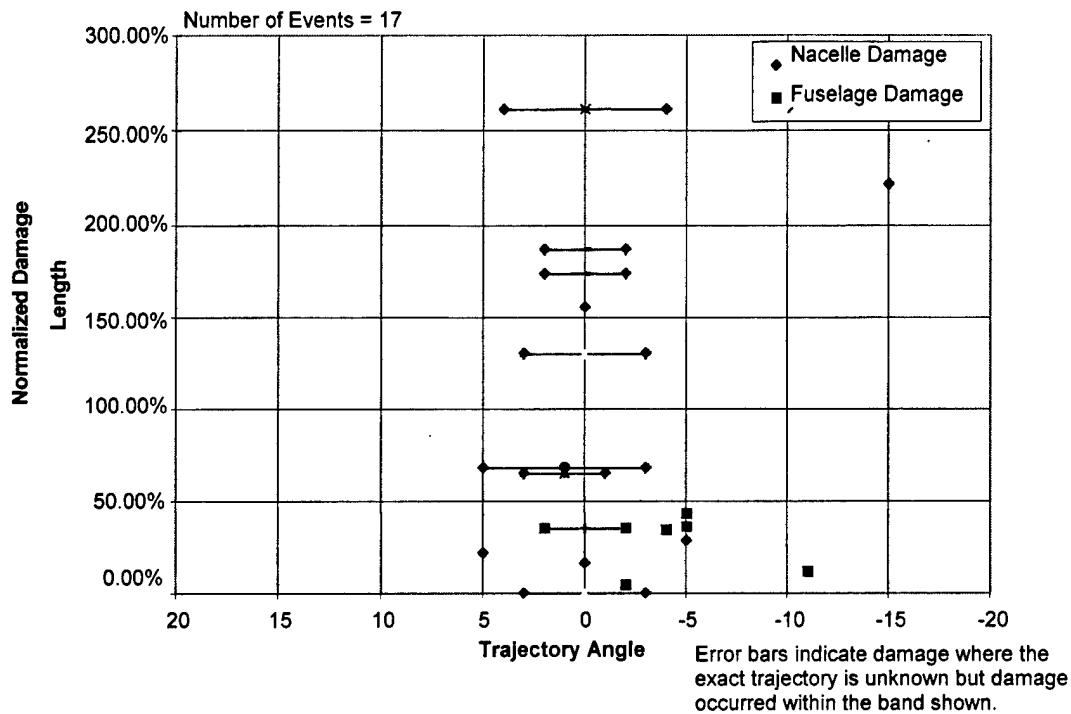
FIGURE 1. ALL EVENTS TRAJECTORY PLOT

An overview of the available trajectory data is shown in figure 1. Data is shown for nacelle and fuselage damage. Trajectory angles are positive for forward trajectories and negative for aft trajectories. It is evident that nacelle damage is typically significantly larger than the failed component dimensions.

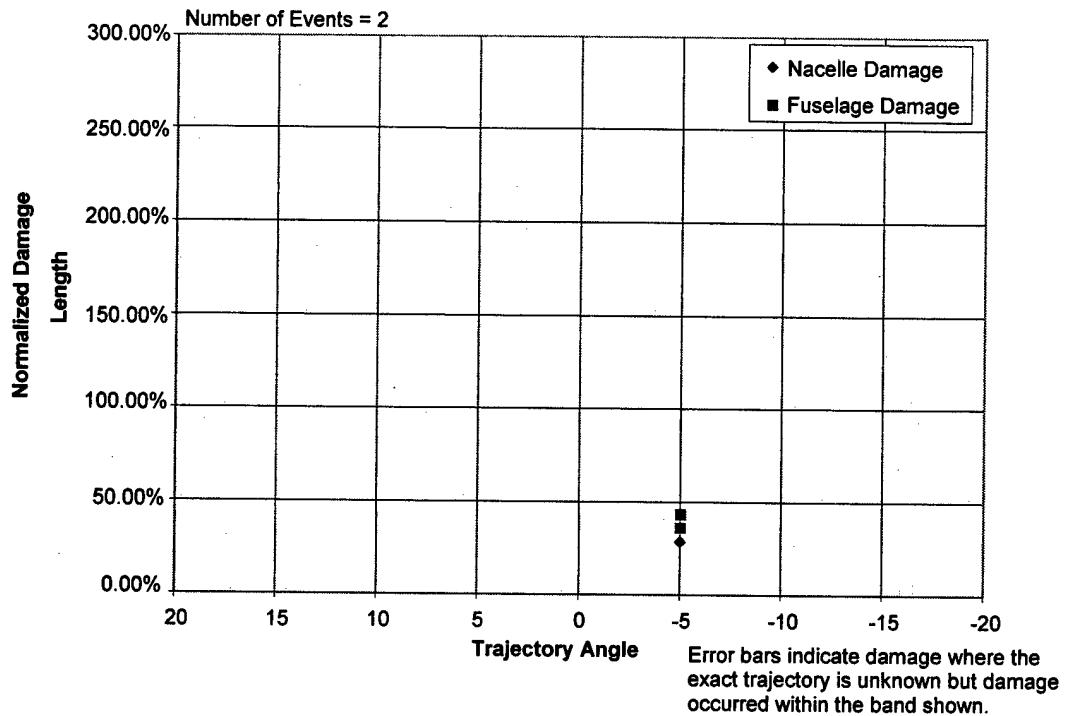
FIGURE 2. COMPRESSOR EVENTS TRAJECTORY PLOT

COMPRESSOR FAILURES. There are five incidents with compressor failures. Three of the events were rim failures with one blade and disk failure respectively. Damage and trajectory data are provided for two of the events (figure 2). Of these two events, one was a disk event (figure 3) and one was a rim event (figure 4). All of the damage was reported at a -5-degree trajectory angle. The damage ratio is less than 50% of the disk diameter in all cases.

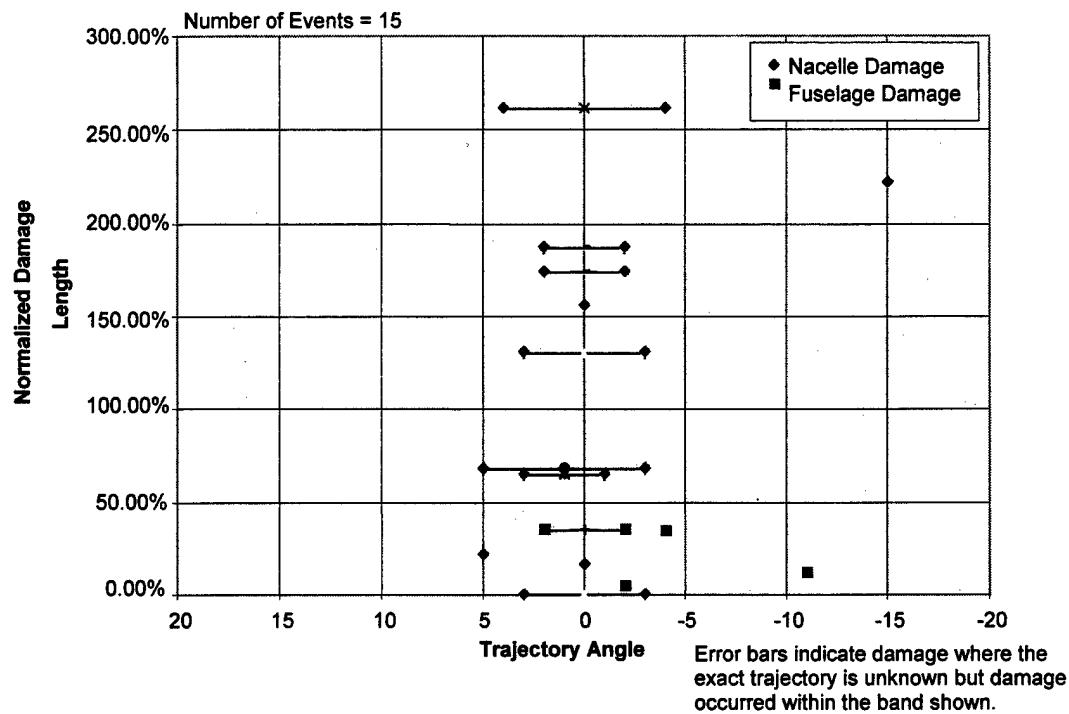
FIGURE 5. TURBINE EVENT TRAJECTORY PLOT

TURBINE FAILURES. The majority of the incidents reported were from turbine failures, 34 uncontained events. Fifteen were turbine rim failures, and 13 were turbine disk failures. Of the 34 events, only 15 reports contain trajectory and damage data (figure 5). Seven of these reports include the general forward and aft spread angle that the debris exited the nacelle. The majority of the data falls within a \pm 5-degree spread angle. Damage to the nacelle has been reported as large as 2.60 times larger than the disk diameter. Fuselage damage was reported as less than 50% of the disk diameter in all cases. Trajectories for the debris damage to the nacelle ranged from 5 degrees forward to -15 degrees aft. Damage to the fuselage ranged from 2 degrees forward to -11 degrees aft.

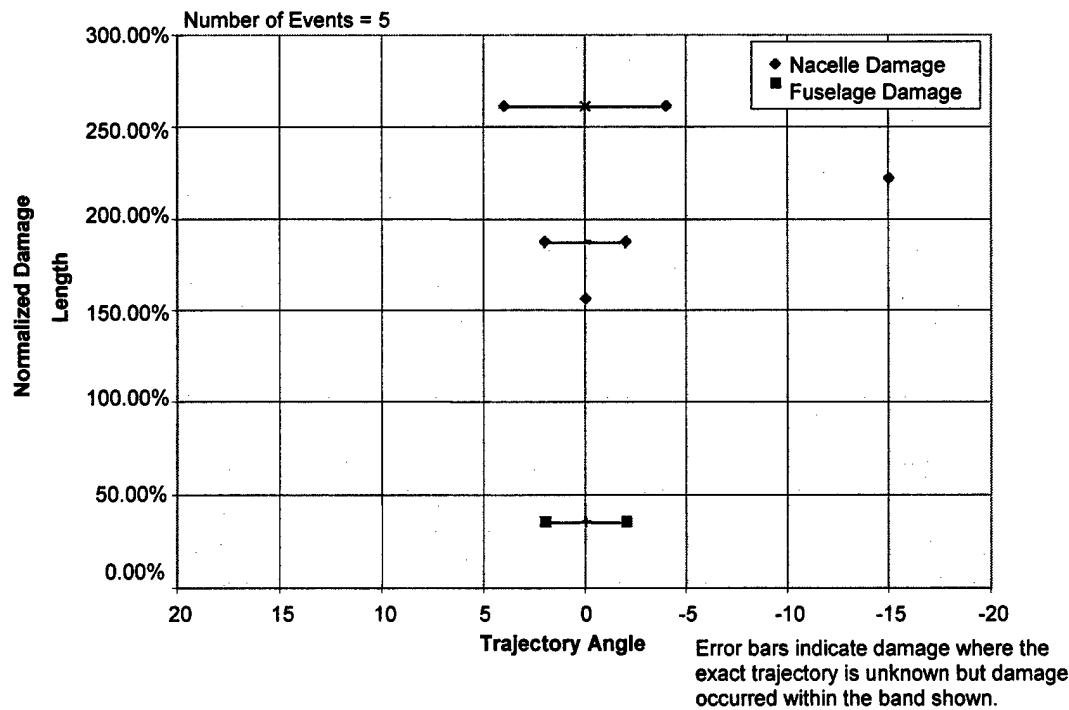
FIGURE 6. TURBINE DISK EVENT TRAJECTORY PLOT

Five turbine disk events were recorded with only one reporting damage to the aircraft fuselage (figure 6). In this case, damage was reported with a trajectory spread of \pm 2 degrees. The trajectory spread for the turbine disk fragments is \pm 4 degrees with an outlying point located at -15 degrees.

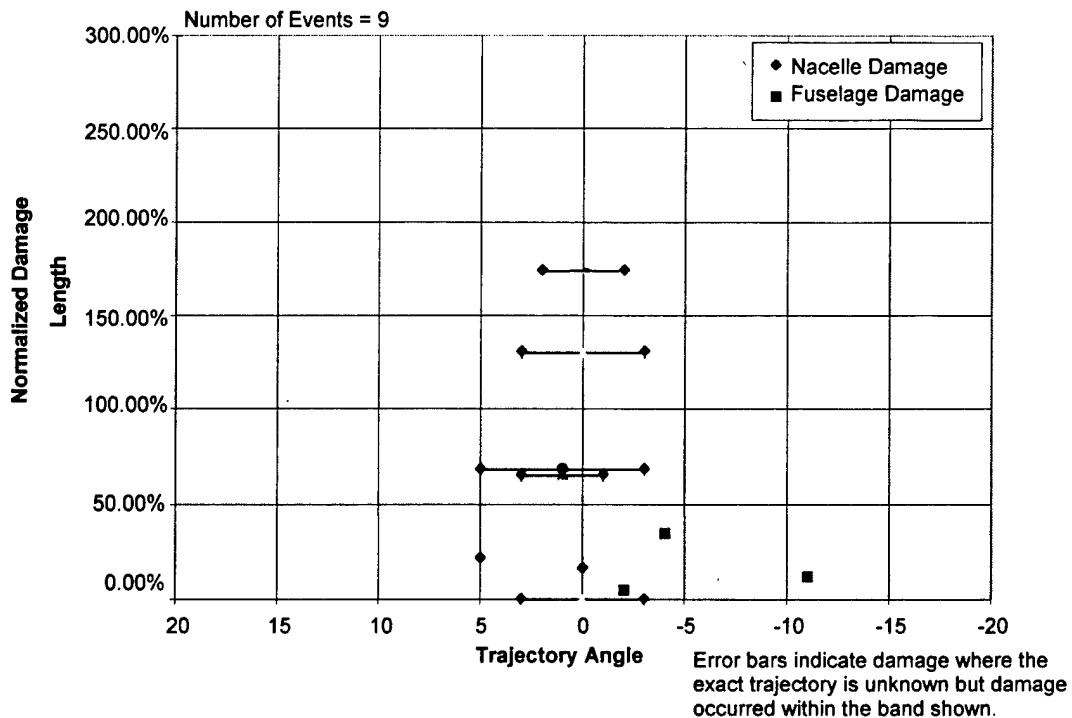
FIGURE 7. TURBINE RIM EVENT TRAJECTORY PLOT

Nine turbine rim events were recorded, only one of which reported damage to the fuselage (figure 7). For this case, three damage locations were noted. The other events, for the most part, recorded trajectory data by noting a spread angle from damage on the nacelle. Fuselage damage for the rim segments ranged from -2 to -11 degrees. The damage size for the fuselage damage was less than 50% of the disk diameter. Nacelle damage spread angles ranged from 5 degrees forward to -3 degrees aft. Nacelle damage was as large as 1.73 times the disk diameter.
